Columbia Center: Sewer Drain and Potable Pipe System Rehabilitation

Location: Downtown San Diego, California

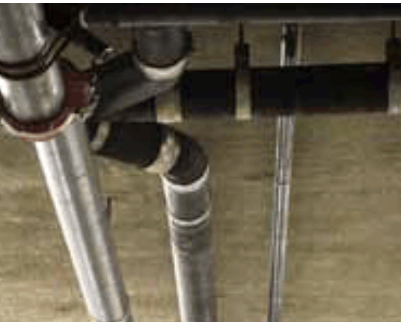
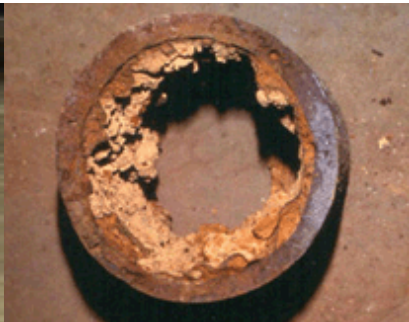
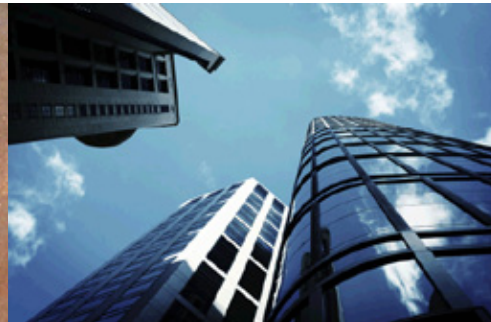
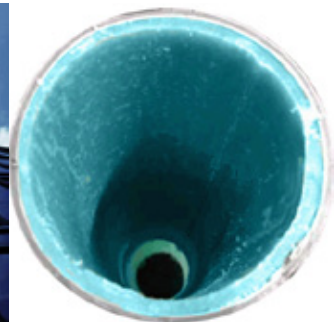
Corroded sewer stacks and potable water stacks were showing their age. The sewer stacks include 228 feet of cast iron drain pipes from the 7th floor to the 25th floor. The potable stacks reach 120 feet to supply drinking fountains and kitchens.

Cleaned and rehabilitated 19 stories of piping to prevent future corrosion and back-ups. Nu Flow's trenchless structural liner and patented epoxy coating solutions did not disrupt workers or destroy the office building's walls, ceilings, finishes and custom wallpaper.
