## ***Elmendorf Air Force Base Hospital: Potable Rehabilitation***

Location: Anchorage, Alaska

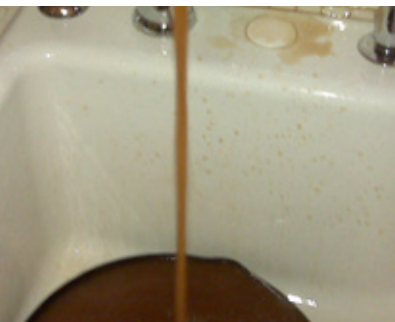
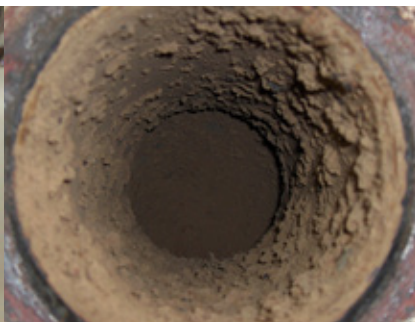
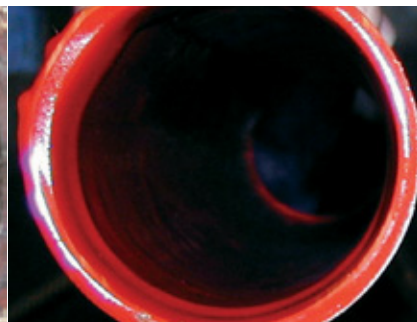
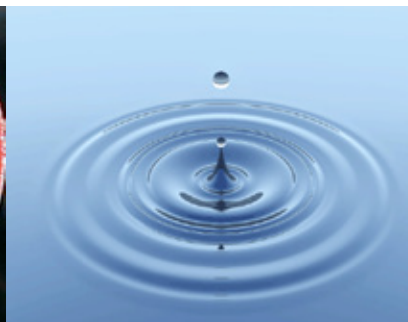
In 1999, the base's \$400 million hospital had just been built. Unfortunately, when soft water ran through the black iron potable lines, it pulled iron out from the pipes, which made the water red. The new hospital could not open until this problem was solved, so a repair was needed quickly.

American Pipe Lining, a Nu Flow company, had the perfect solution for the customer. Our blown-in epoxy coating was applied via existing access points to the pipes, so there was no demolition to the new building. Technicians coated about 2 miles of pipes, ranging from 3" to 8" in diameter.
