California State University, Los Angeles: HVAC System Rehabilitation

Location: Los Angeles, California

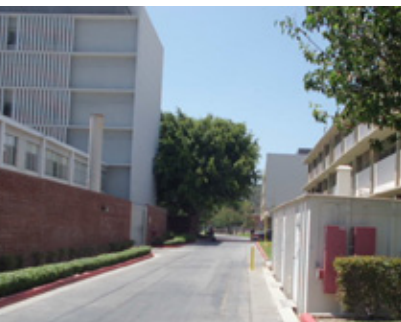
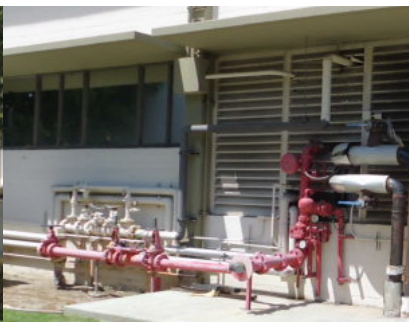
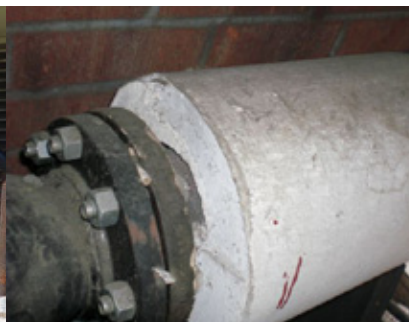
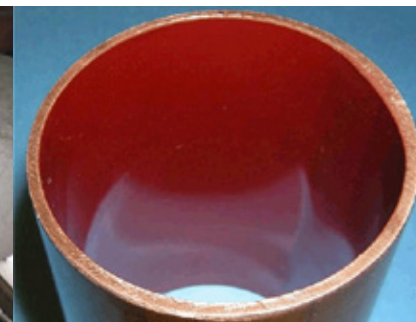
The supply and return lines for the three-story Fine Arts building's HVAC system experienced leaks. The 5" and 6" steel pipes are more than 50 years old and run approximately 15 feet beneath a busy service road that the university could not close for repairs.

Nu Flow's no-dig technology was the only feasible solution for the customer because it was cost-effective and did not cause destruction or disruption to the campus' normal operations. Nu Flow installed a spot repair liner to the leaks and then applied epoxy to the HVAC system to prevent future problems.
